To re-align the gears:

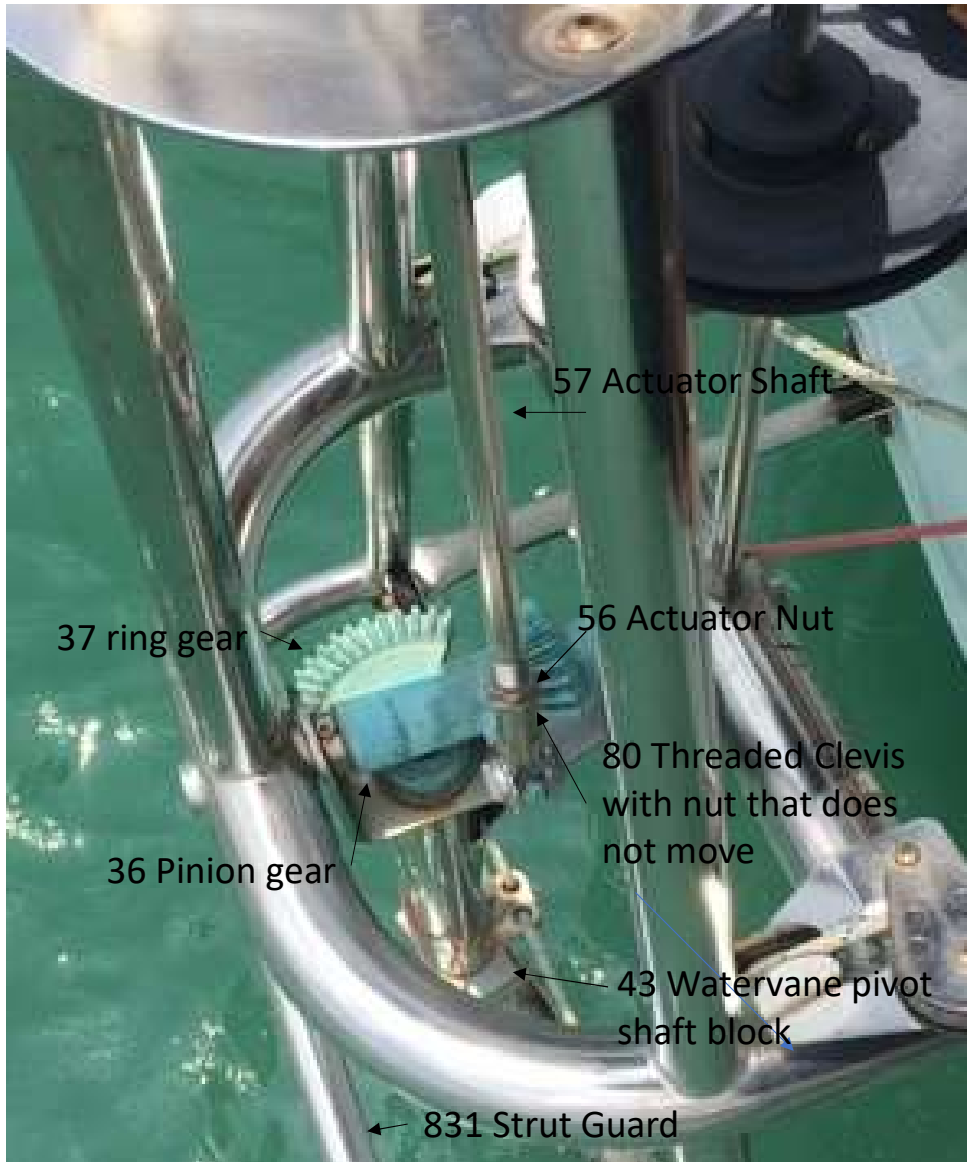
Note the position of the actuator nut (part no. 56) with a marker or by counting the visible threads.

Loosen the actuator nut and completely unscrew the actuator shaft (part no. 57) from the threaded clevis (part no. 80).

With the actuator shaft disconnected, you can now manipulate the gears back into position. The first tooth on the starboard side of the pinion gear (part no. 36) fits into the first groove of the starboard side of the ring gear (part no. 37). It is marked with an arrow on the gear. See section 6.3.3 of the Monitor manual.

Screw the actuator shaft back into the threaded clevis until the block at the bottom of the watervane pivot shaft is dead fore-and-aft. You can sight the edge of the block on the strut guard (part no. 831), or attach the paddle to make sure it is properly lined up.

Now point the airvane clamp (part no. 78, not shown) dead fore-and-aft with the lead counterweight aft.

Once everything is lined up, tighten the actuator nut down to lock it in place.
