# NEW LATCH AND SPRING RETROFIT

Installing a new-style Latch #47 onto an older Monitor.

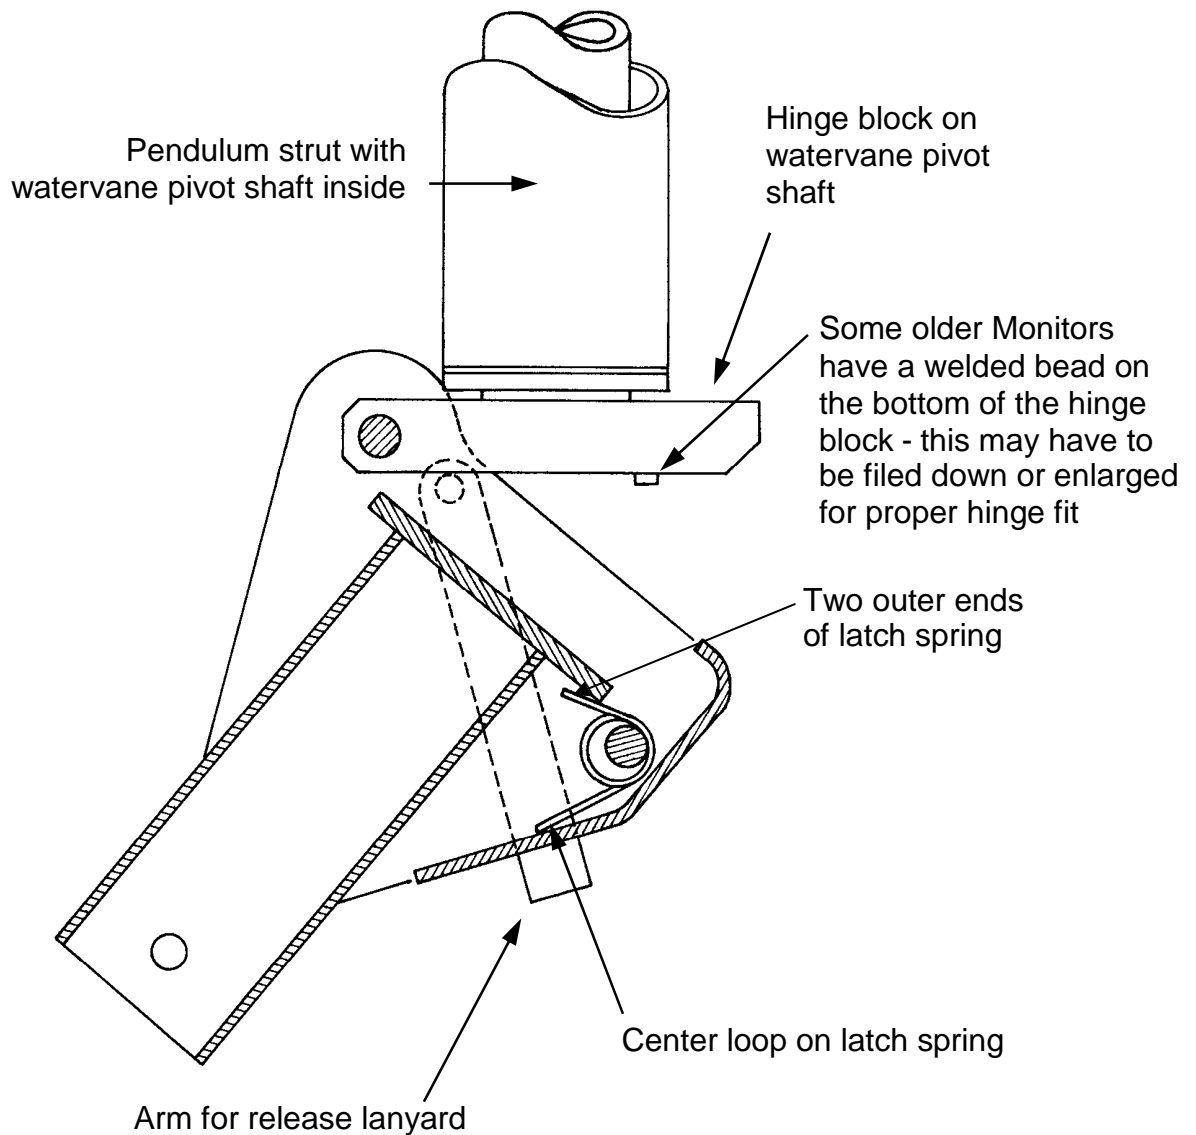
The new-style latch, introduced in 1994, has a rearward-facing arm to which a release lanyard is attached.

NOTE: New-style Latch Spring #48 is needed with the new Latch #47

For serial number 1500-22189R on - may not fit older Monitors.
